THE RIC REPORT

**123 Main Street
Greenville, SC 29605
Prepared for: Mr. and Mrs. Buyer**

RESIDENCE TO BE INSPECTED:
Street Address: 123 Main Street
City, State, Zip Code: Greenville, SC 29605

Inspection Date: 10/08/2015 **Inspection Time:** 01:00 PM
The fee for this inspection is \$395.00
payable (check one) [] at the time of inspection [] at closing
 If fee is to be paid at closing, please include the closing date and closing attorney below:

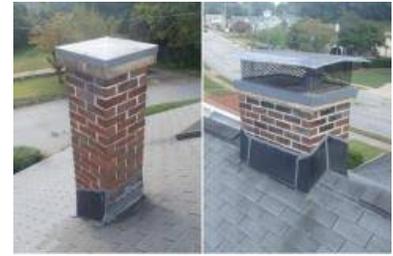
CONDITION: Acceptable.

MATERIAL: Brick and Mortar.
CHIMNEY CAP: Chimney caps are installed.
FLUE LINER: Did Not View.
ROOF JOINT: The chimney/roof joint is in Good condition.
